BEAVER POND DAM

**NDI No. PA 00133
PennDER No. 64-19
Dam Owner: Marguerite Card**

**PHASE I INSPECTION REPORT
NATIONAL DAM INSPECTION PROGRAM**

Beaver Pond Dam, Wayne County, Pennsylvania
NDI No. PA 00133, PennDER No. 64-19
Unnamed Tributary of Shadigee Creek
Inspected 28 October 1980

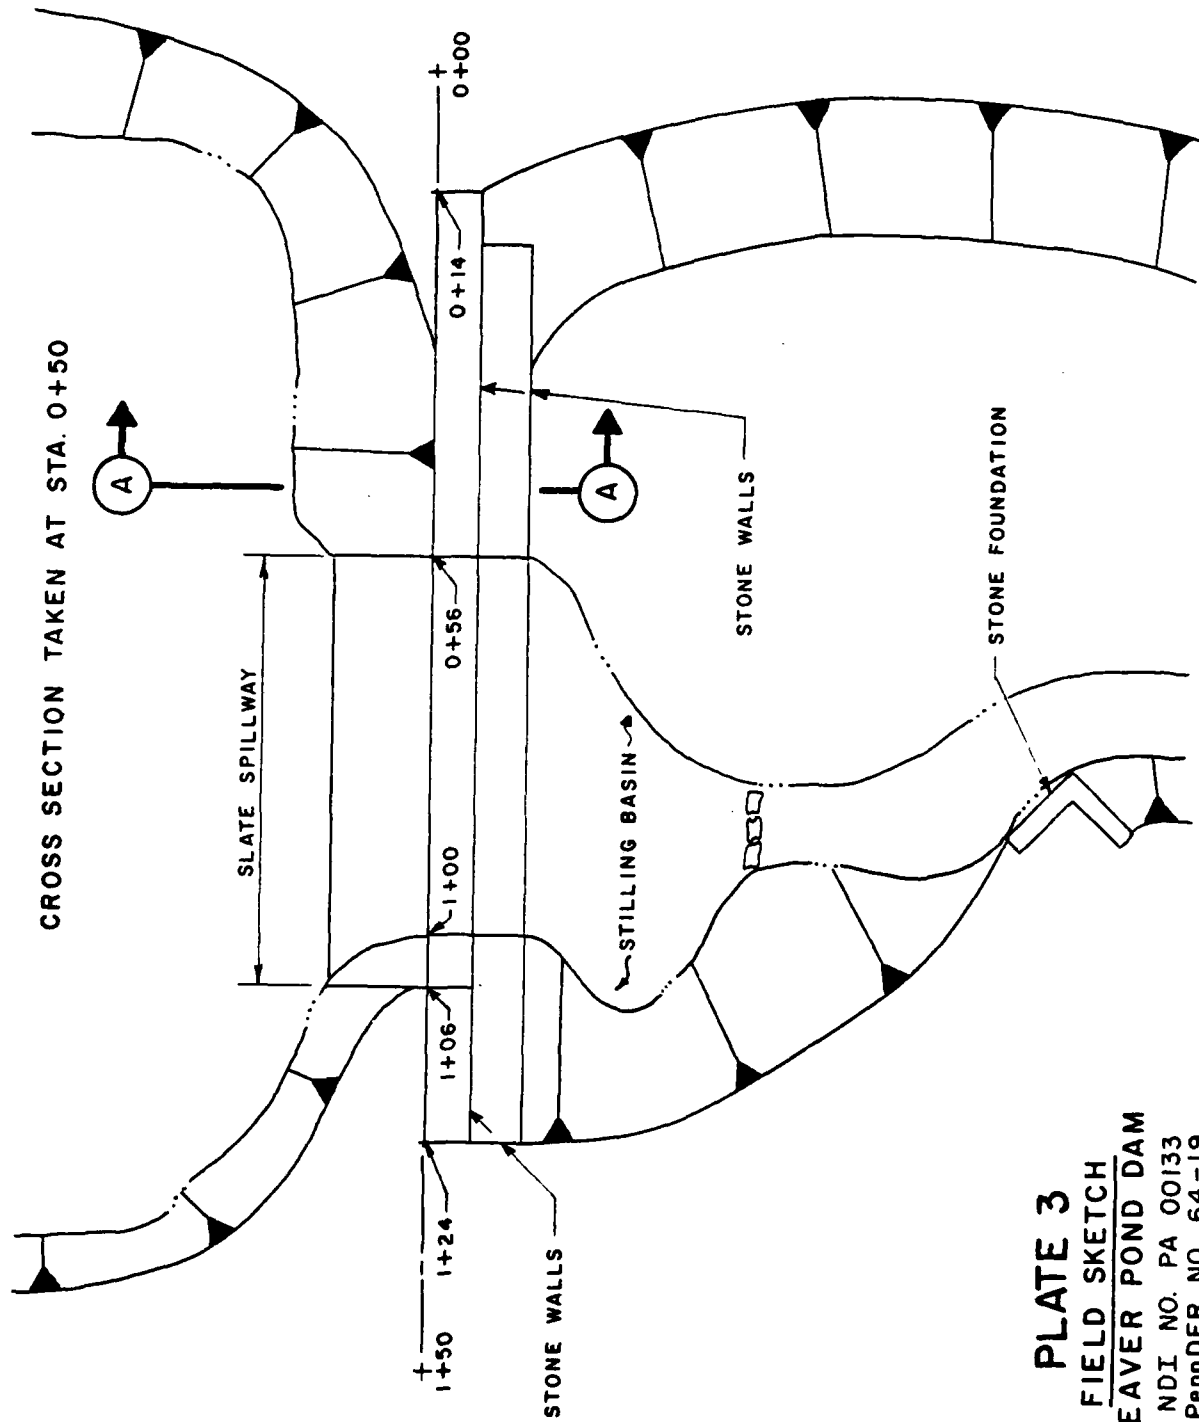
PLATE 3
FIELD SKETCH
BEAVER POND DAM
 NDI NO. PA 00133
 PENN. DER. NO. 64-19
 SCHEMATIC - NOT TO SCALE

- b. Dam - The timber cribbing on the left half of the dam has rotted considerably. It is recommended that this cribbing be repaired. Rodent holes were observed on the right half of the dam where the dam is covered with a thin layer of soil. Thick brush is growing on the left side of the dam and below the downstream toe of both sides of the dam.
